Sinking of U.S. Fish Processing Vessel *Alaska Ranger*
Bering Sea, March 23, 2008

NTSB/MAR-09/05
PB2009-916405

Marine Accident Report

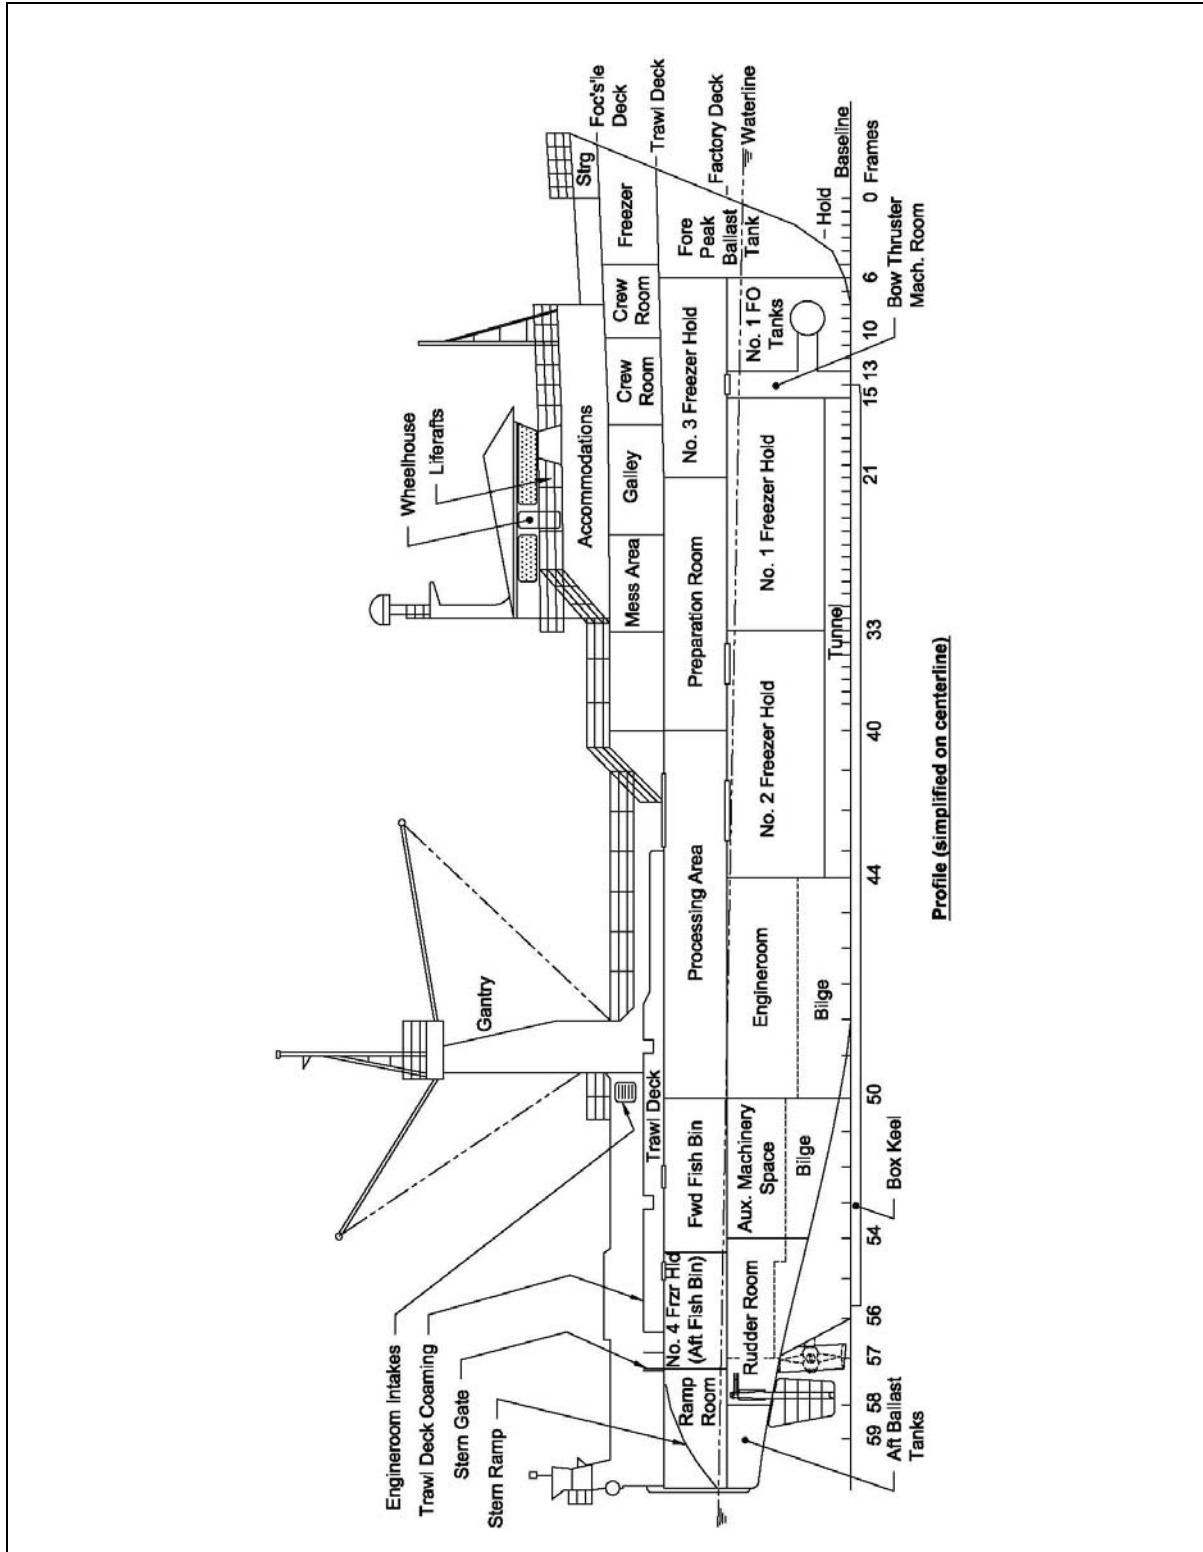
Figure 3. Profile view of *Alaska Ranger*. Flooding involved the aft compartments on the hold and factory decks. Most crewmembers were asleep in quarters on the foc's'le and forward trawl decks when flooding began. Liferafts were stored next to the wheelhouse above the foc's'le deck. (FO = fuel oil)

Two of the Japanese crewmembers testified that they went through the auxiliary machinery space to the engineroom and saw water leaking above the watertight door to the rudder room, where two freezer pipes penetrated the bulkhead separating the auxiliary machinery space from the rudder room (see figure 3). As instructed by the fishmaster, the crewmembers returned several times to the engineroom to monitor the flooding. One said that the last time he was in the engineroom, the water in the bilges was approximately 1 meter (39 inches) below the deck plates. According to vessel drawings, the engineroom bilges ranged from 6 to 8 feet deep (forward to aft).

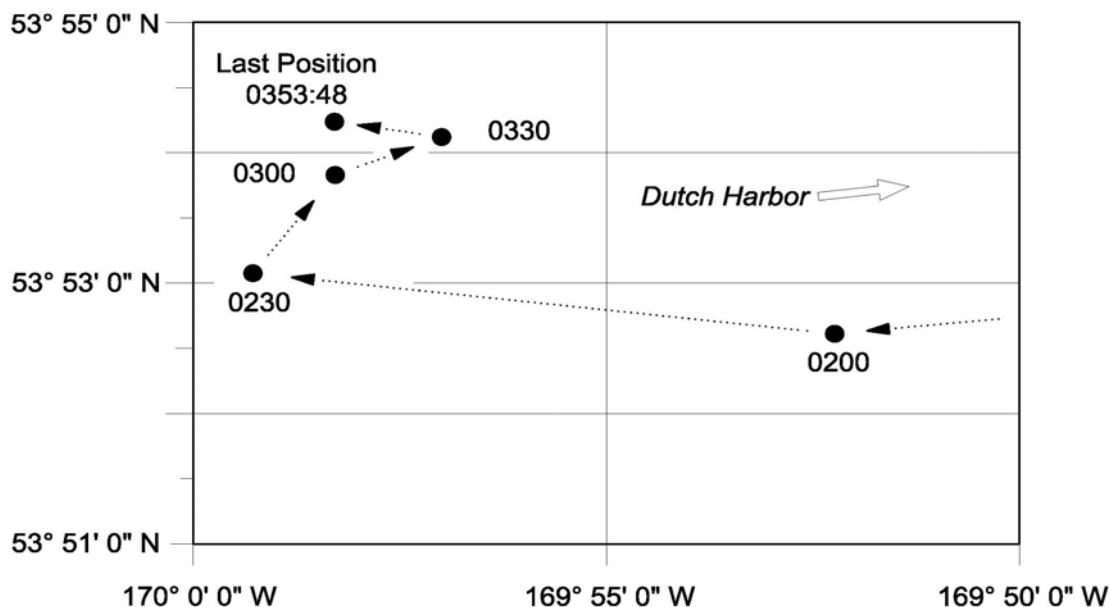
Figure 4. Vessel's position before it sank, from data transmitted every half hour by vessel monitoring system. The *Alaska Ranger's* position is shown from about 30 minutes before flooding was discovered (0230) until about 30 minutes before it sank. The vessel reportedly lost electrical power about 0330. Arrows and dotted lines indicate only the vessel's heading—its track between data points was not monitored.

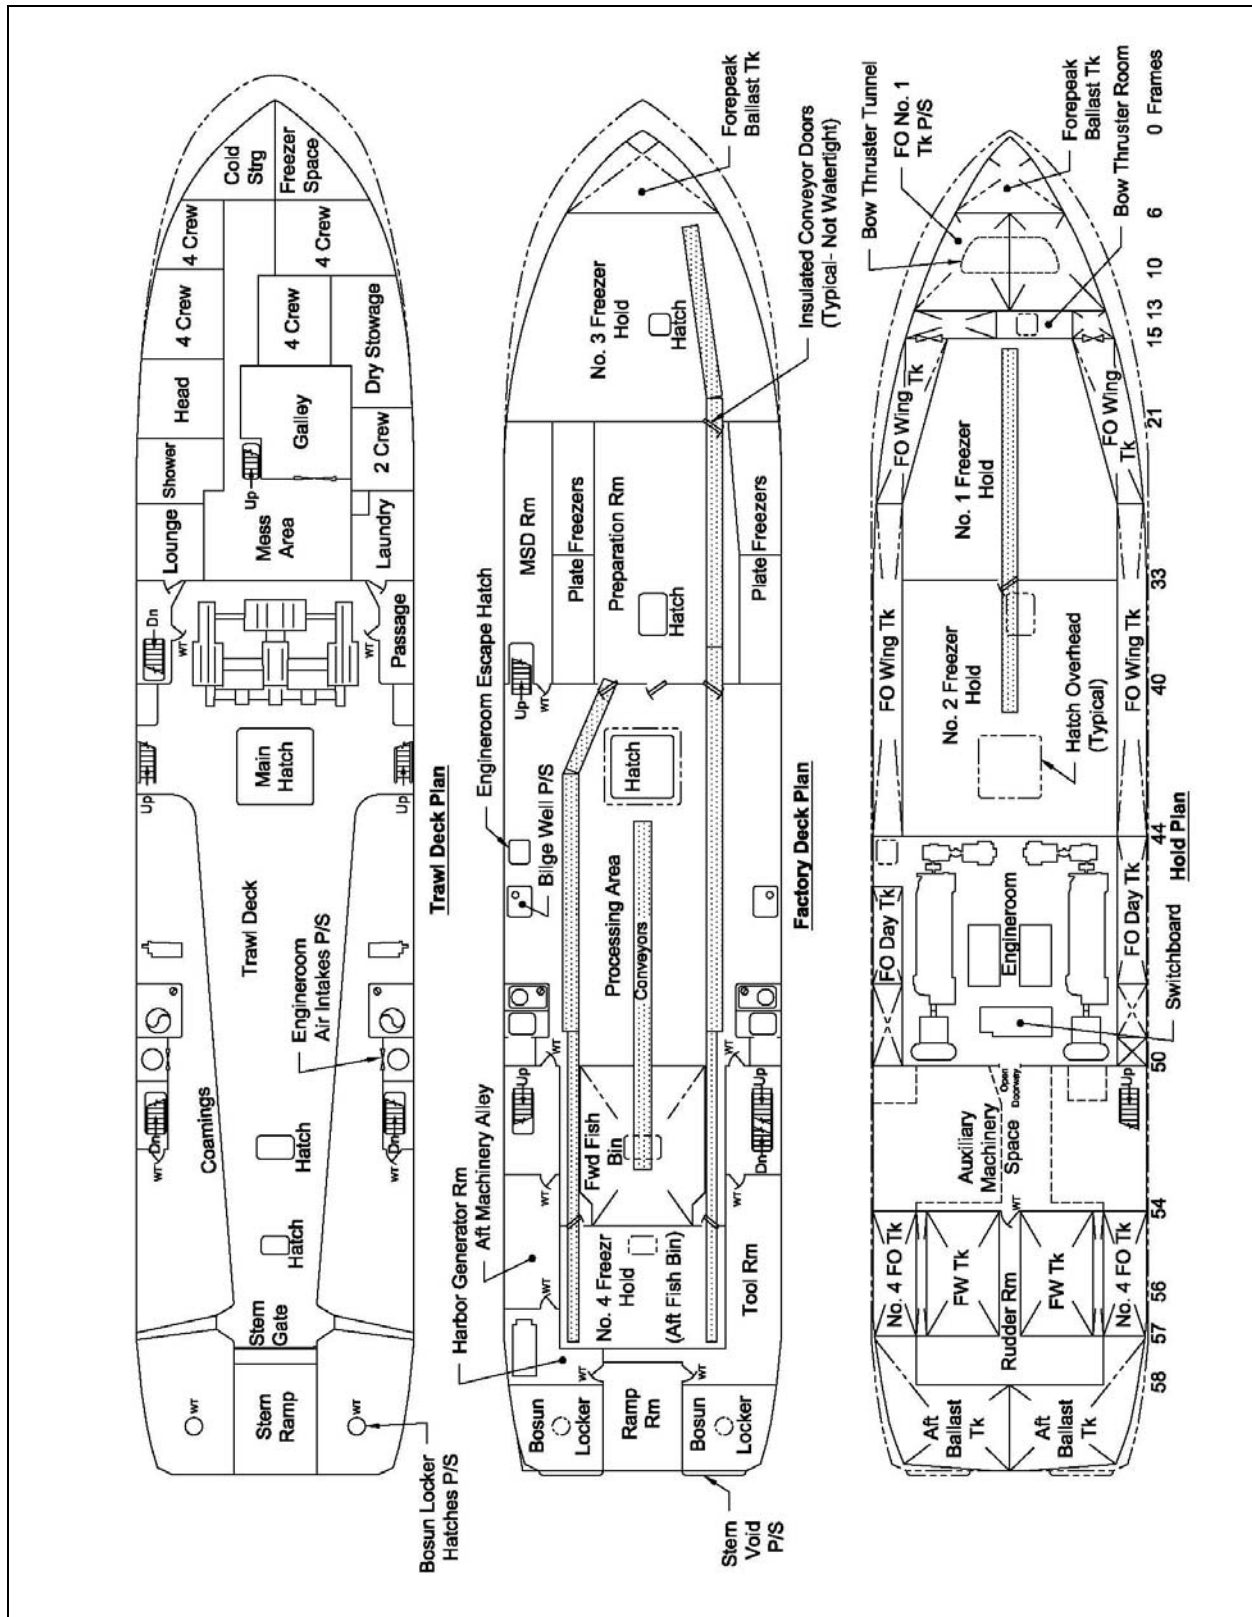
Figure 5. Plan view of *Alaska Ranger* trawl deck, factory deck, and hold. (FO = fuel oil; FW = freshwater; MSD = marine sanitation device; P/S = port and starboard; Tk = tank; WT = watertight)

The company's electrical engineering contractor told the Marine Board that the bulkhead penetrations through which cables and wires passed were watertight. The bulkhead dividing the auxiliary machinery space from the engineroom was not watertight, being broken by an open archway and by cutouts for the engine shafts. A single watertight door separated the auxiliary machinery space from the rudder room. The door between the No. 1 and No. 2 freezer holds was not watertight (refer to figure 5).

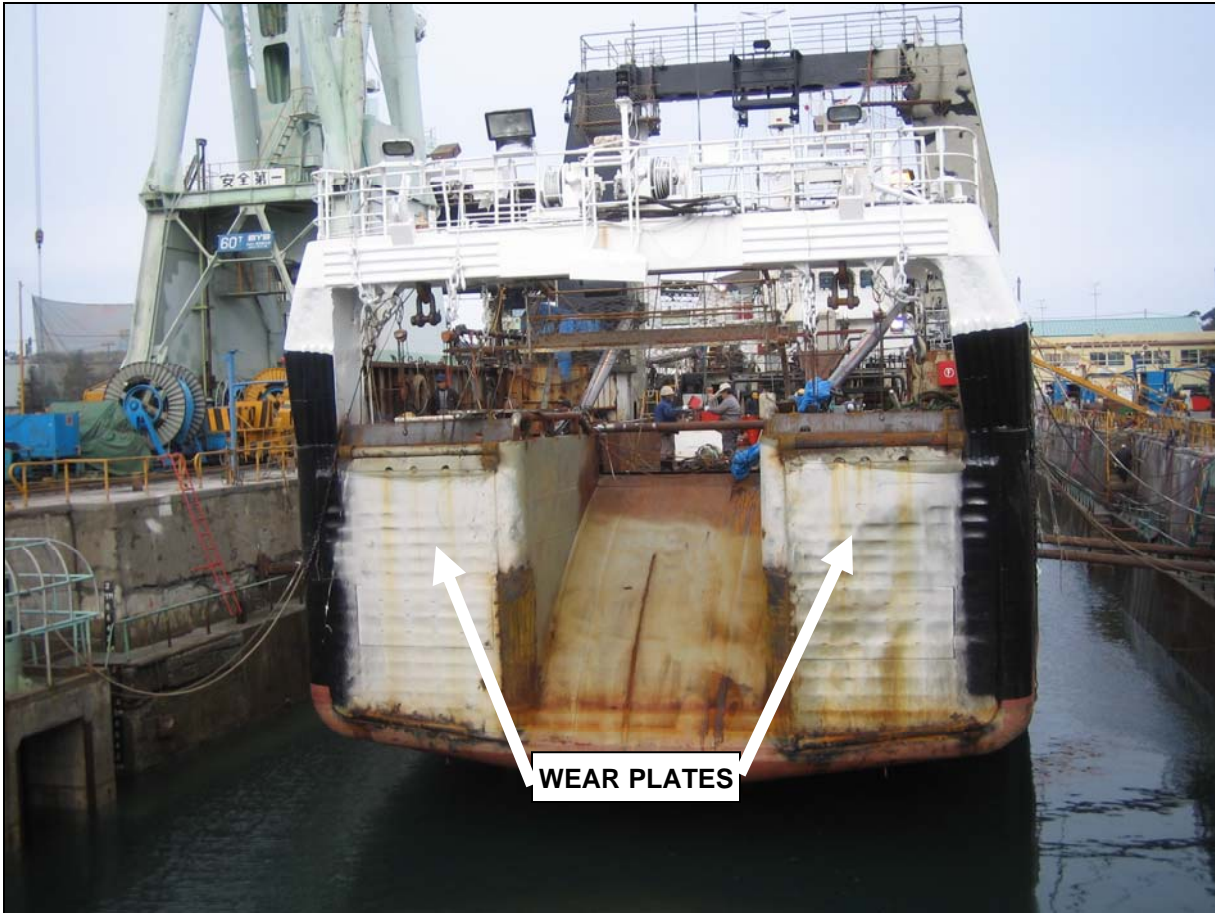
Wear plates were fitted to the stern to protect it against strikes by the trawl doors (figure 6). The wear plates, each about 15 feet high by 12 feet wide, were welded to frames. The frames were welded to the stern, creating inaccessible void spaces approximately 6–8 inches deep.

Figure 6. Wear plates fitted over stern of *Alaska Ranger*, shown in 2005. Stern ramp in the center allowed nets to be launched into the sea and then hauled on board with their catch.

The stern, including the wear plates and the interior plates next to the void spaces, was not gauged during the drydock examination, according to the chief Coast Guard examiner. Nor was gauging done on the interior or exterior plates of the stern ramp. Vessel drawings show that the interior plates of the stern were accessible from the aft ballast tanks. The ACSA examination booklet used in the drydock examination states that “gauging shall include . . . internals of the fore and after peak tanks.” The Coast Guard examiner who conducted the examination told the Marine Board, “There’s no reason to take shots [do audio gauging] on the stern because there’s a wear plate back there. . . . from visually what [the other inspectors] said, there was no excessive corrosion on the inside of the aft bulkhead, or fracturing.”

The 2007 ACSA drydock examination resulted in a 31-item list of corrective work for the *Alaska Ranger*. While the vessel was in drydock, weld repairs were made to the wear plates at the vessel’s stern and temporary repairs were made to the forward ballast tanks. At the time of the accident, the following items remained on the list of corrective work, according to Fishing Company of Alaska: (1) provide two-way communication from each fixed fire-pull station and wheelhouse; (2) replace halon activation bottles in engine room; (3) update fire control plan; (4) naval architect to calculate and provide addendum to stability booklet identifying all watertight and weathertight doors and openings, all sea valves, and calculations for dewatering sump pumps in factory area (also, have naval architect calculate location of waterline mark and then repaint mark); (5) free port and starboard engine room intake covers; (6) remove cam lock fitting on No. 3 port fuel tank cover in factory; (7) install visual and audio indicators in wheelhouse for factory high-water alarms; (8) repair bulkhead separating port and starboard aft ballast tanks³³; (9) install flame arrestor bowls for all fuel filters on the main engines, generators, and bow thruster.

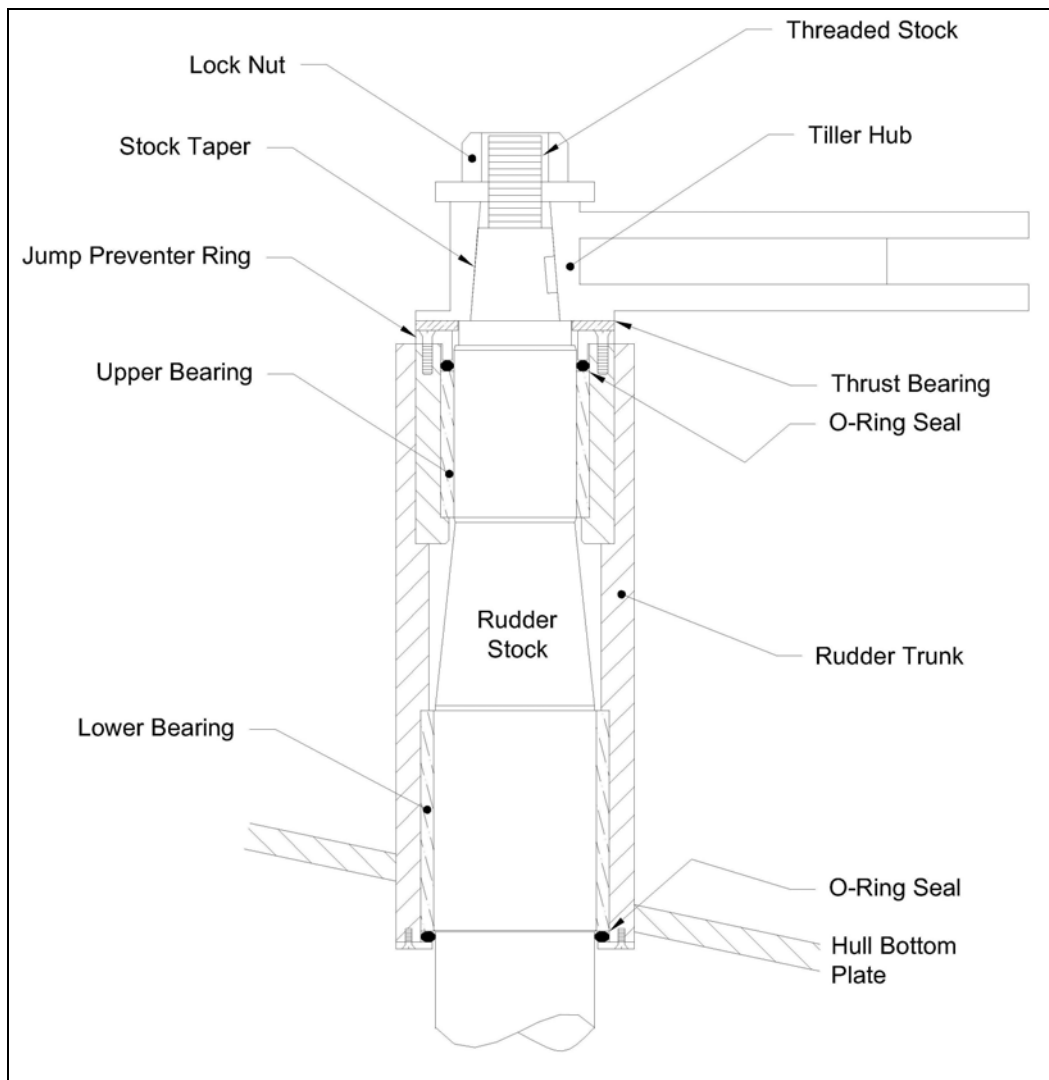
Figure 7. Section view of *Alaska Ranger* rudder assembly, developed from original ship’s drawings. The rudder assembly extended about 5 feet above the hull bottom plate.

arm securely to the rudder stock. The owner of the company's engineering services firm stated that the tiller on the starboard rudder had come loose in 1990, but that the problem had not recurred. He said that if the shrink fit on the taper of the tiller had been compromised, the lock nut would have been strong enough to hold the rudder at sea in calm water (static conditions), but that in heavy weather (dynamic conditions), a compromised shrink fit could have caused the rudder "to just flap . . . eventually we will have a problem."

Crewmembers reported that the rudders leaked seawater before the accident. The day-watch assistant engineer estimated the leakage at a gallon a minute, but he stated that the leakage was "pretty much regular." The port engineer stated that leakage from the rudder thrust bearing was normal, but "you wouldn't expect to see it gushing out." He further stated that the thrust bearing was greased "at least once or twice" per shift "to keep the water leakage down." The main function of the grease was, however, to lubricate the contact between the bearing plates.
