Sinking of U.S. Fish Processing Vessel *Alaska Ranger*
Bering Sea, March 23, 2008

NTSB/MAR-09/05
PB2009-916405

Marine Accident Report

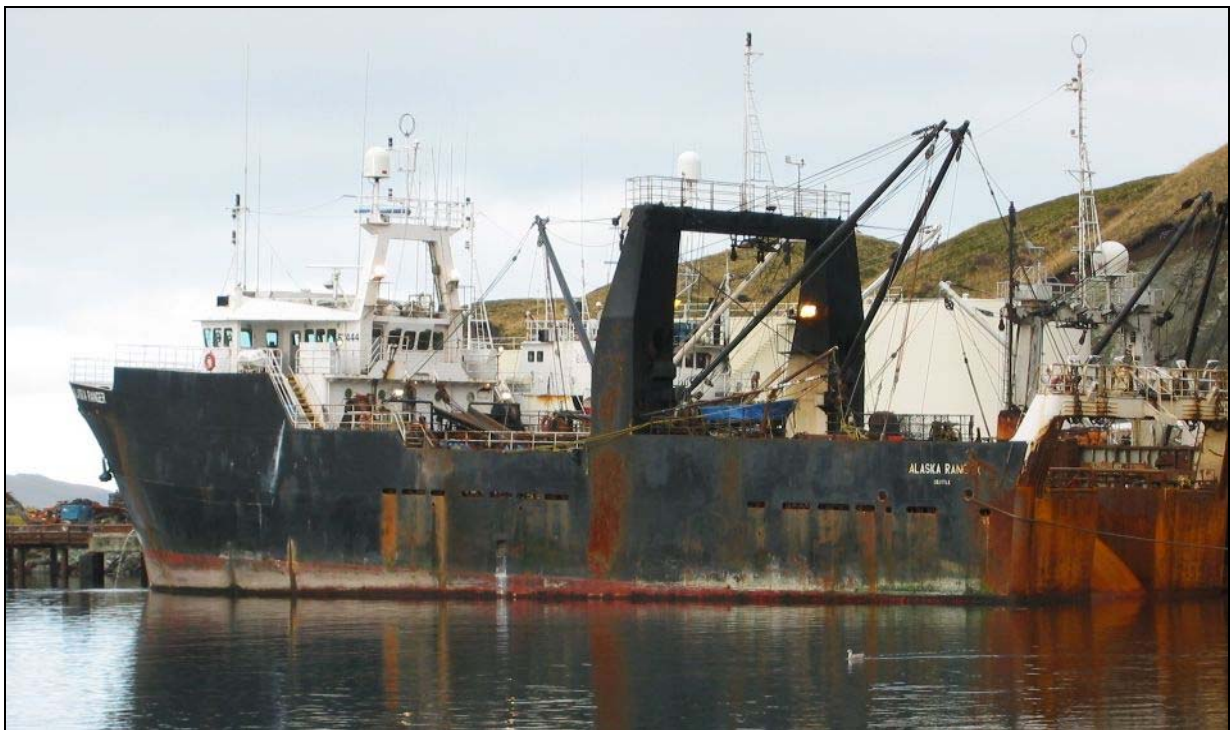
Figure 1. *Alaska Ranger* docked in Dutch Harbor, Alaska, November 2002. Vessel's wheelhouse is the white structure on the left. Another fishing vessel and an oil tank are partially visible behind the *Alaska Ranger*. (Photo courtesy U.S. Coast Guard)

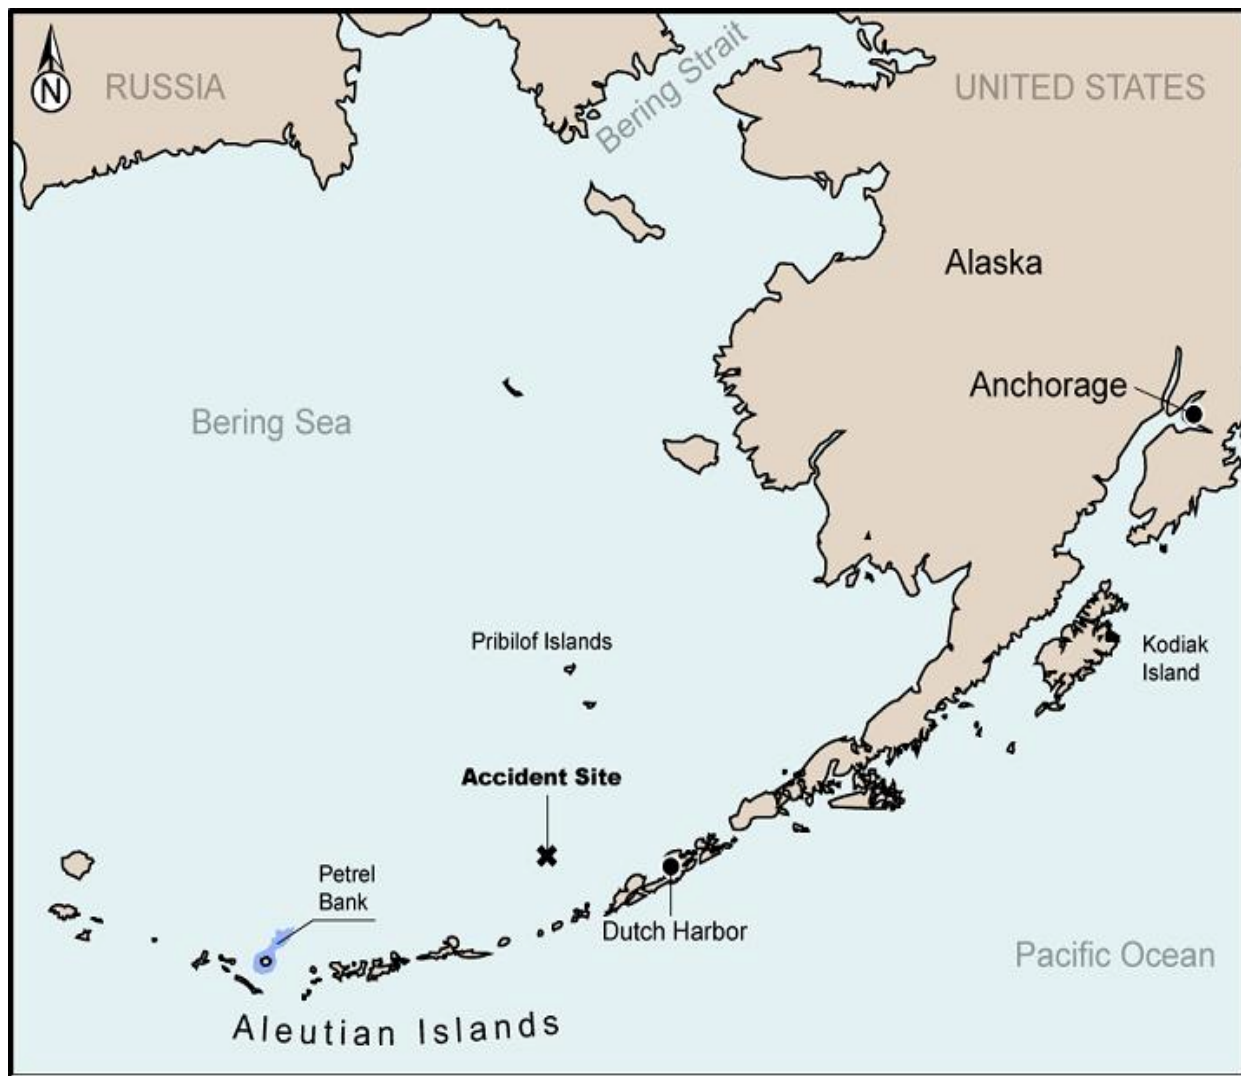
On Friday, March 21, 2008, while fishing for groundfish (yellowfin sole) in the Bering Sea, the *Alaska Ranger* encountered southward-moving ice that pushed it out of the fishing grounds. The vessel returned to the Aleutian Island port of Dutch Harbor, where the crew changed nets and other gear to fish for mackerel. Shortly after noon on Saturday, March 22, the *Alaska Ranger* departed Dutch Harbor for Petrel Bank, a fishing ground 500 nautical miles³ to the west and away from the ice (figure 2).

Figure 2. Area of Bering Sea where *Alaska Ranger* sank.

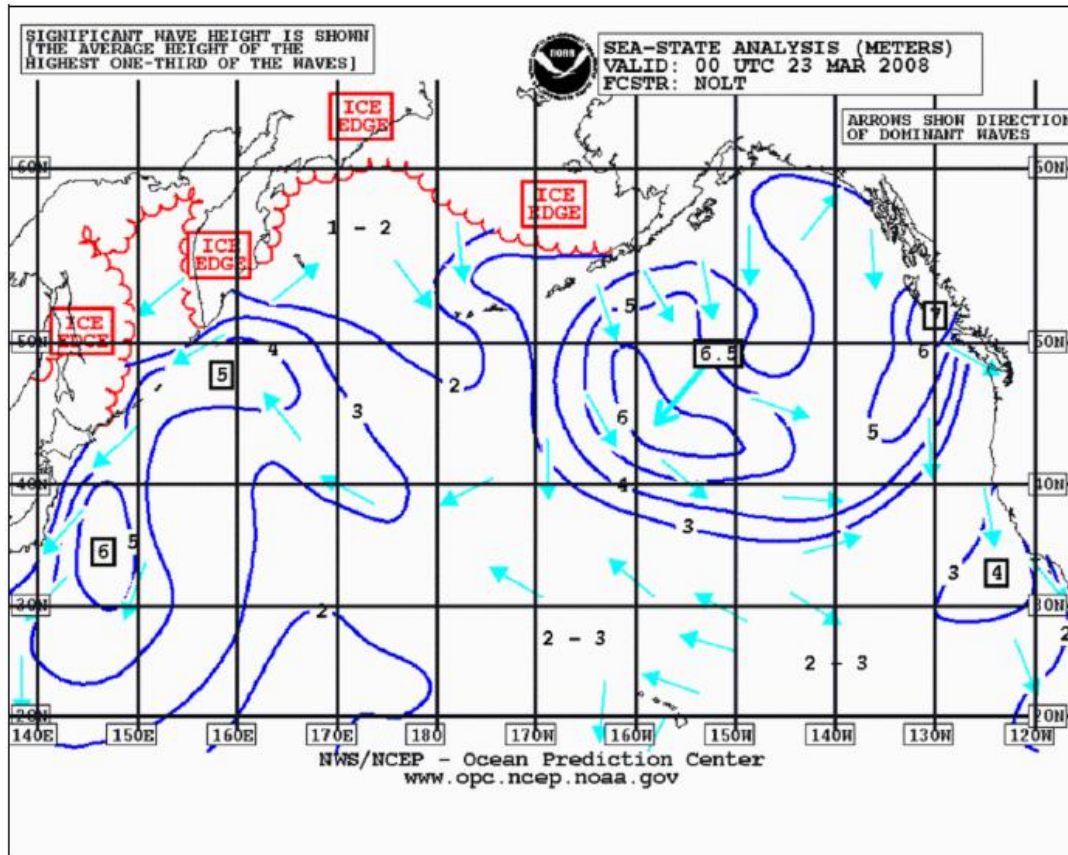
As noted earlier, the *Alaska Ranger* had returned to Dutch Harbor 2 days before the accident because of ice in the Bering Sea fishing grounds where it had been working. The National Weather Service publishes a Marine Weather Service Chart of Alaskan waters showing ice limits, forecast areas, and radio stations that transmit marine weather and other information of interest to mariners. The National Weather Service's significant sea-state analysis for the north Pacific on the afternoon before the sinking shows the edge of the sea ice extending over the northeast Bering Sea, from the Alaska peninsula to the north of Dutch Harbor (figure 8).

Figure 8. Extent of sea ice in Bering Sea at 1600 on day before sinking (March 22, 2008). Sea ice, which forms when the ocean’s saltwater freezes (at about 29° F), differs from icebergs, which are freshwater chunks of ice shelves or glaciers that break off into the ocean.
